24. Crushed by Elevator

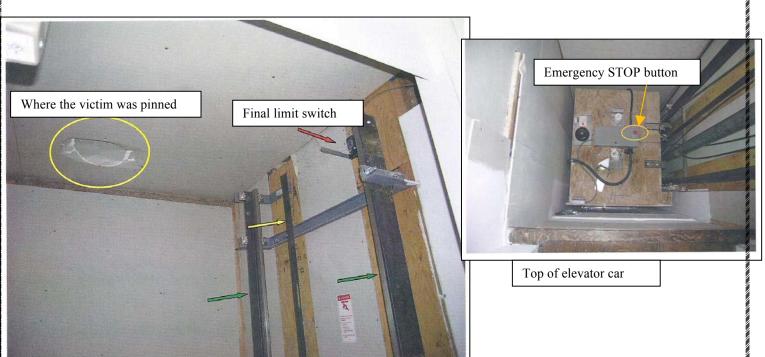
A 38-year-old elevator service-and-repair-man was killed when he was pinned between the top of an elevator and the top of the elevator shaft. The victim and a technician were sent to a private residence to determine and repair the source of a bump or noise that the homeowner reported was occurring while the elevator was in operation. The victim was riding on top of the elevator car troubleshooting and the technician was inside the car operating the controls. The victim directed the technician to raise or lower the car in the shaft to facilitate locating the bump or noise. There was an emergency STOP button on top of the car-top electrical box and, in addition to other controls, an emergency STOP button in the car. At some point, as the car was travelling from floor 2 toward floor 3 with the victim riding on the top, he became pinned between the car and the top of the shaft. The car was trying to go to floor 3 and would not stop because it was not high enough to actuate a magnetic reader or the top final limit switch that would tell the electronic controller that the car had arrived at floor 3. Once he discovered that the victim was pinned, the technician attempted to collapse the wall of the elevator car by kicking it to allow the roof to collapse. The technician and the home owner worked to saw through the car's overhead to allow the roof to fall in. The technician then attempted to open all the hydraulic system valves and bleed off the hydraulic pressure to allow the car to lower. He also tried to cut the hydraulic supply line to bleed off the pressure. Only this last effort was successful and as the car lowered, the technician and the home owner pulled the victim free onto the floor 3 landing. It is unclear why neither the technician nor the victim actuated their respective emergency STOP switches. Emergency services were called to the scene, but the victim did not survive.

Top of elevator shaft
